**Annual Inspection Report Troy Municipal Airport**

# AUGUST 3, 2011

## **ANNUAL INSPECTION REPORT**

TROY MUNICIPAL AIRPORT
TROY, ALABAMA

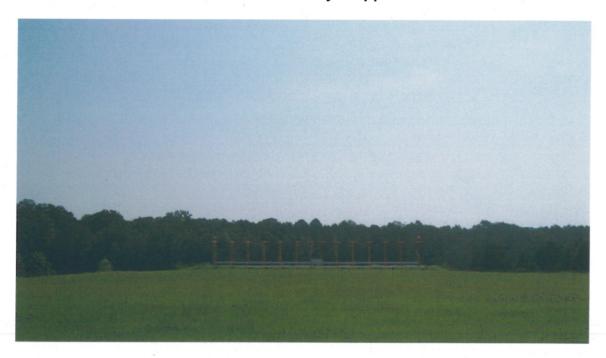
Photo #1 - Runway 7 Approach

- Runway 07 No obstructions (See Photo # 1).
- Runway 25 No obstructions (See Photo # 2).
- Runway 14 No obstructions (See Photo # 3).
- Runway 32 Trees identified as Tree # 2, # 4 and # 5 obstruct the ALDOT approach/departure path and Tree # 1 and # 6 obstruct the approach slope within the limits of the FAA runway protection zone (See Photo # 4, # 5 & Appendix 2).

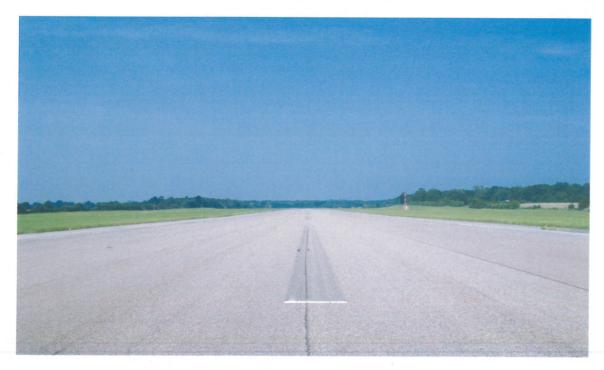
The airport markings are in good condition, with the exception of runway 7/25's center line which is poor due to fading (See Photo # 6).

Center line markings for runway 7/25 should be replaced in accordance with FAA AC 150/5340-1K.

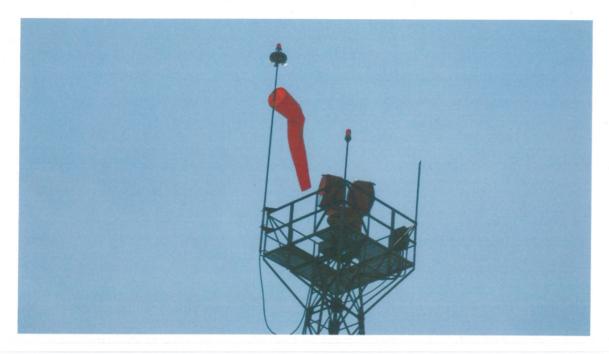
The wind direction indicator (wind cone) is operational and the fabric is in good condition (See Photo # 7).

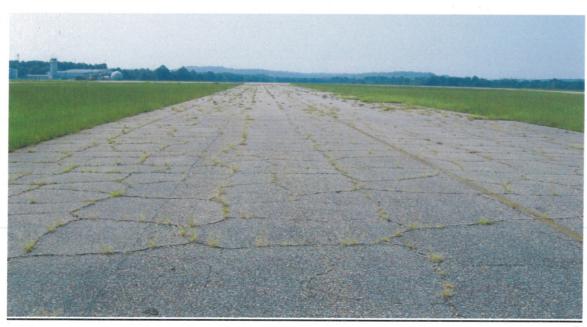
• The apron and runway surfaces are in good condition, as well as the parallel taxiway for runway 7/25; however the parallel taxiway for runway 14/32 is in poor condition. There is widespread severe block cracking with vegetation growing from the cracks. The condition is bordering on failed and may be of limited service in the near future (See Photo # 8).

Reconstruction will be required of the taxiway in the near future.

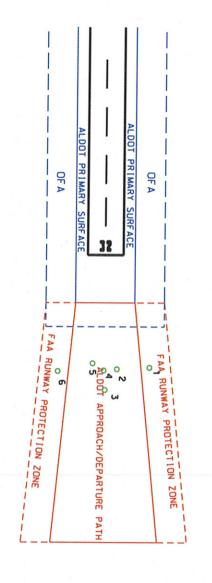
# REQUIREMENTS FOR STATE AIRPORT LICENSE RUNWAY 32

- TREE 22.2' ABOVE RUNWAY END 507' FROM RUNWAY END 188' RIGHT OF CENTERLINE 13:1 OBSTRUCTION CLEARANCE SLOPE
- ņ 480' FROM RUNWAY END
  50' RIGHT OF CENTERLINE
  13:1 DBSTRUCTION CLEARANCE SLOPE TREE - 21.3' ABOVE RUNWAY END
- 21:1 OBSTRUCTION CLEARANCE SLOPE ON CENTERL INE 564' FROM RUNWAY END TREE - 17.3' ABOVE RUNWAY END
- 483' FROM RUNWAY END 5' LEFT OF CENTERLINE 19:1 OBSTRUCTION CLEARANCE SLOPE TREE - 14.8' ABOVE RUNWAY END
- 5. 52' LEFT OF CENTERLINE 14:1 OBSTRUCTION CLEARANCE SLOPE TREE - 17.2' ABOVE RUNWAY END 456' FROM RUNWAY END
- 525' FROM RUNWAY END 199' LEFT OF CENTERLINE TREE - 22.2' ABOVE RUNWAY END 14:1 OBSTRUCTION CLEARANCE SLOPE
- \* NOT AN ALDOT OBSTRUCTION

While these trees are representative of obstructions in the approach departure path of runway 32 they may not be the only trees that violate the 20:1 approach/departure path, and all obstructions must be removed for an operating license to be issued.
